## BEACH EROSION CONTROL REPORT ON COOPERATIVE STUDY

# FALMOUTH MASSACHUSETTS

WALTHAM, MASS. DECEMBER 28, 1962

BEACH EROSION CONTROL REPORT ON COOPERATIVE STUDY OF FALMOUTH, MASSACHUSETTS

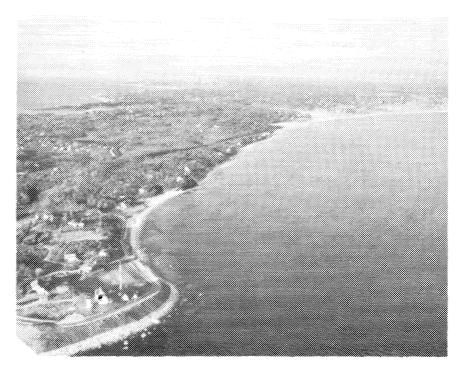
PHOTO 1 NOBSKA POINT TO FALMOUTH BEACH Nov 27, 1961 - Nobska Point in foreground

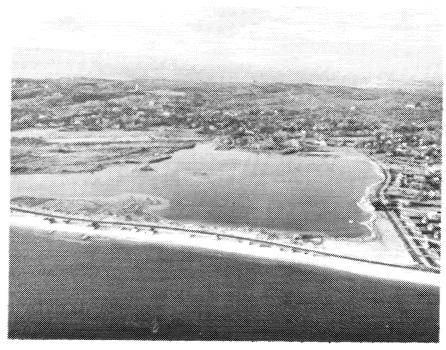
PHOTO 2 FALMOUTH BEACH (CENTRAL PORTION)
Nov 27, 1961 - Cottages on low barrier bar

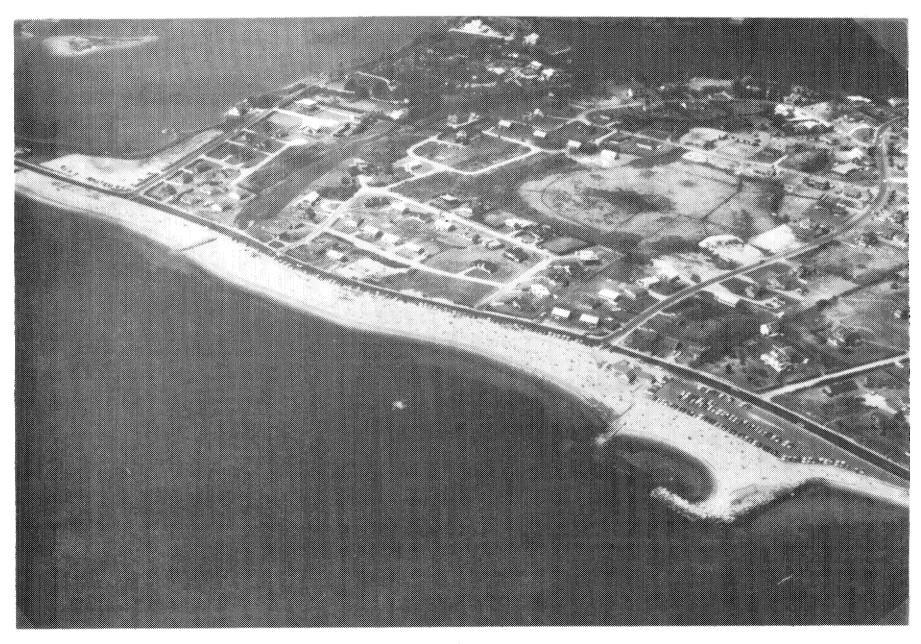
PHOTO 3 FALMOUTH BEACH (EAST END) - Aug 26, 1962. Sunday attendance at the public bathing beach.

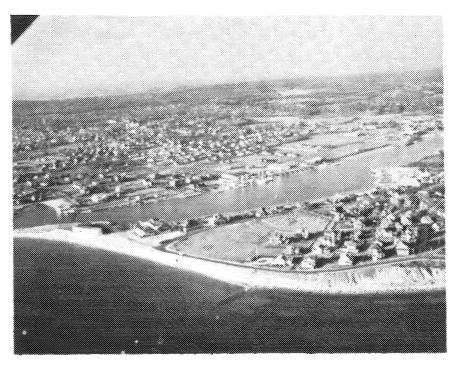
PHOTO 4 FALMOUTH HEIGHTS, Nov 27, 1961 - From Falmouth Inner Harbor entrance to bluffs.

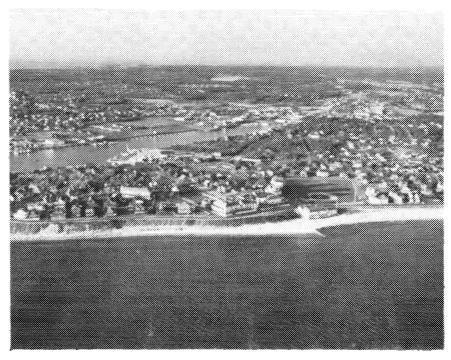
PHOTO 5 FALMOUTH HEIGHTS, Nov 27, 1961 - The bluffs, Casino and public bathing beach

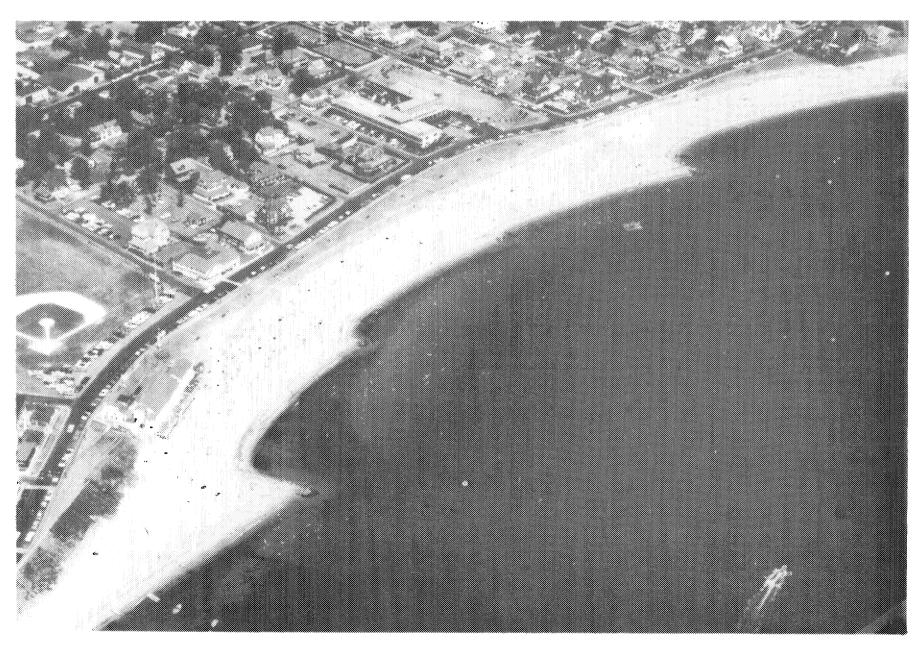
PHOTO 6 FALMOUTH HEIGHTS, Aug 26, 1962. - Sunday attendance at the public bathing beach.

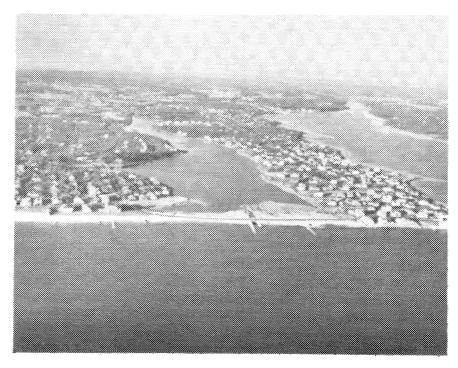
PHOTO 7 FALMOUTH HEIGHTS, LITTLE POND AND MARA VISTA - Nov 27, 1961

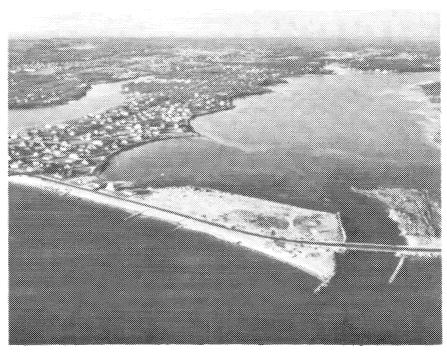
PHOTO 8 MARA VISTA AND GREAT POND INLET Nov 27, 1961

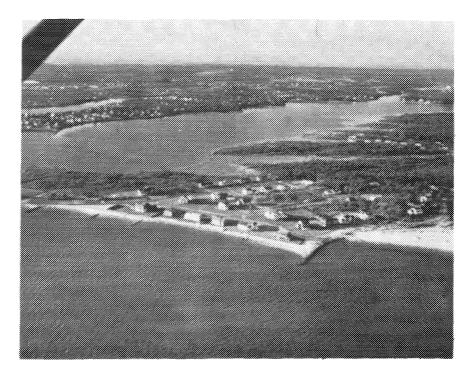
PHOTO 9 ACAPESKET, Nov 27, 1961 - Great Pond in background

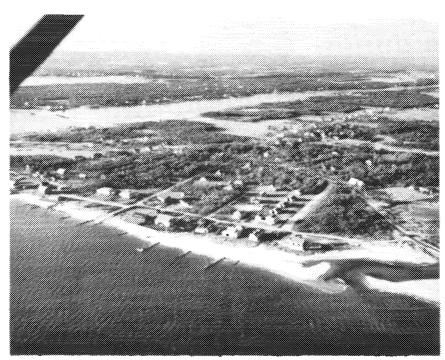
PHOTO 10 DAVISVILLE AND BOURNES POND INLET - Nov 27, 1961

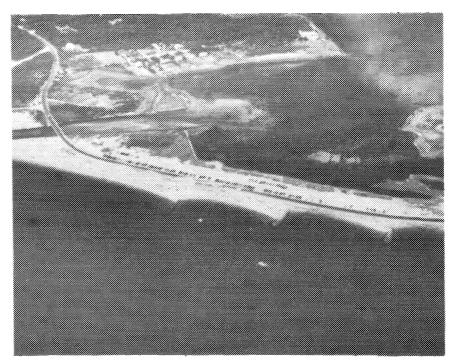
PHOTO 11 MENAUHANT BEACH, Aug 26, 1962 - Sunday attendance at the public bathing beach.

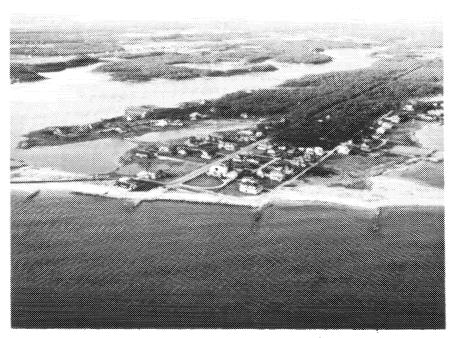
PHOTO 12 MENAUHANT, Nov 27, 1961. - Low shore between Bournes and Eel Ponds

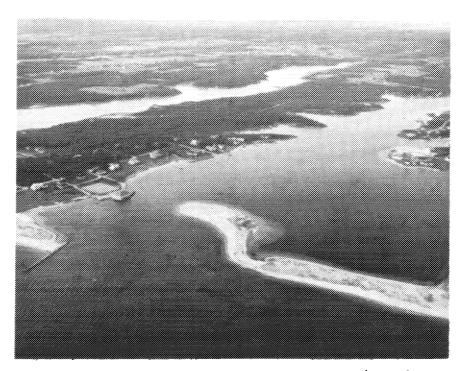
PHOTO 13 EEL POND INLET, Nov 27, 1961 - Three groins stranded offshore by retreat of west end of Washburn Island

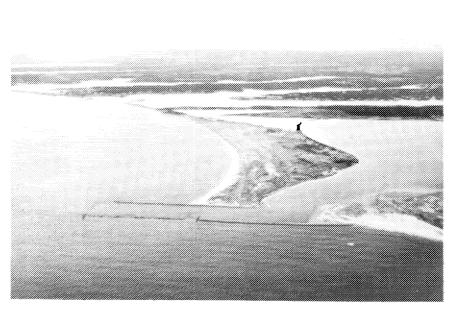
PHOTO 14 WASHBURN ISLAND, Nov 27, 1961 - Extends westward from Waquoit Bay jettied inlet
